Eielson Air Force Base Operable Units 3, 4, and 5

Declaration of the Amended Record of Decision

Site Name and Location
Operable Units 3, 4, and 5
Eielson Air Force Base, Alaska

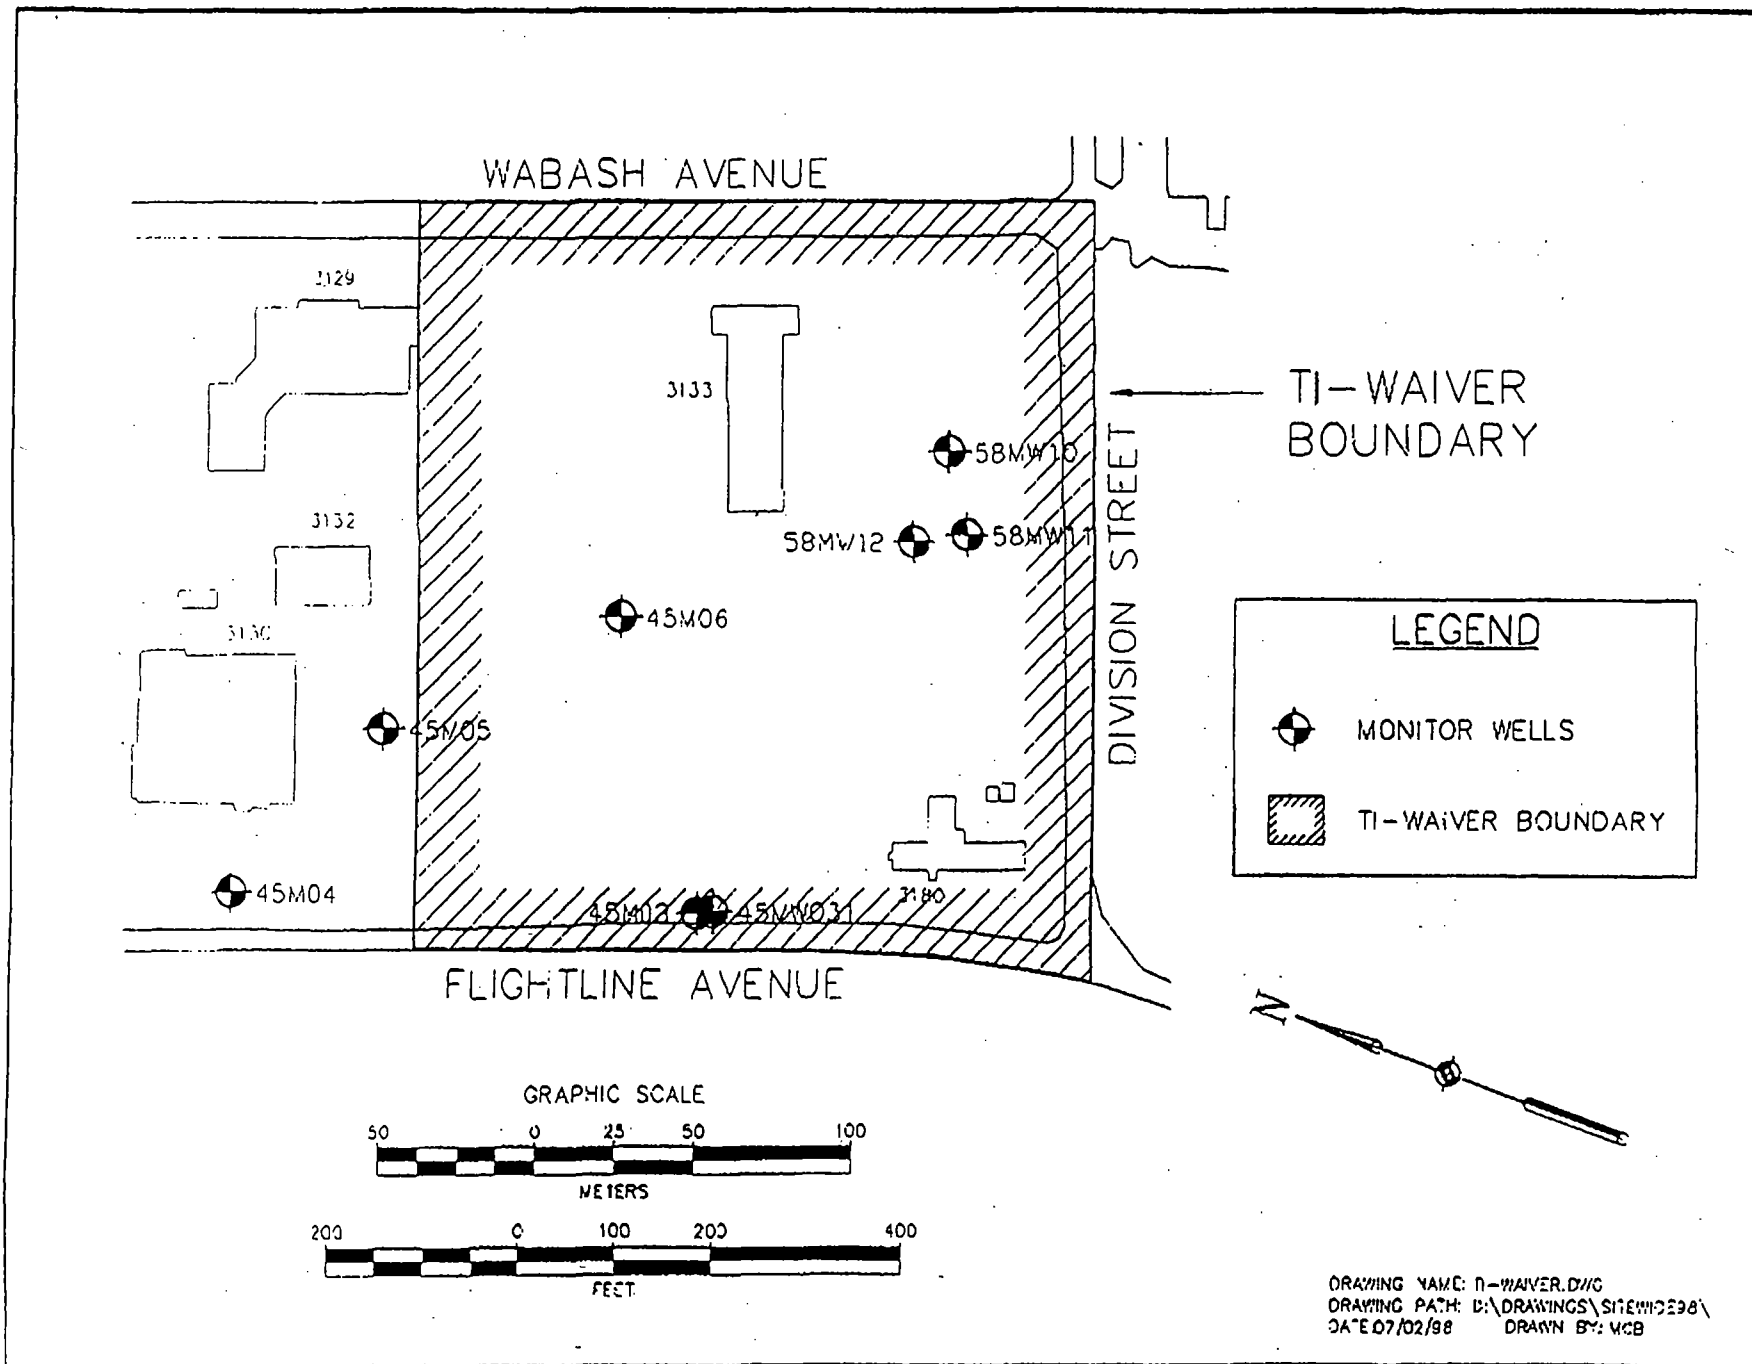
ST58: TI-Waiver Boundary, E on AFB, Alaska
